REPLACEMENT SPRINGS

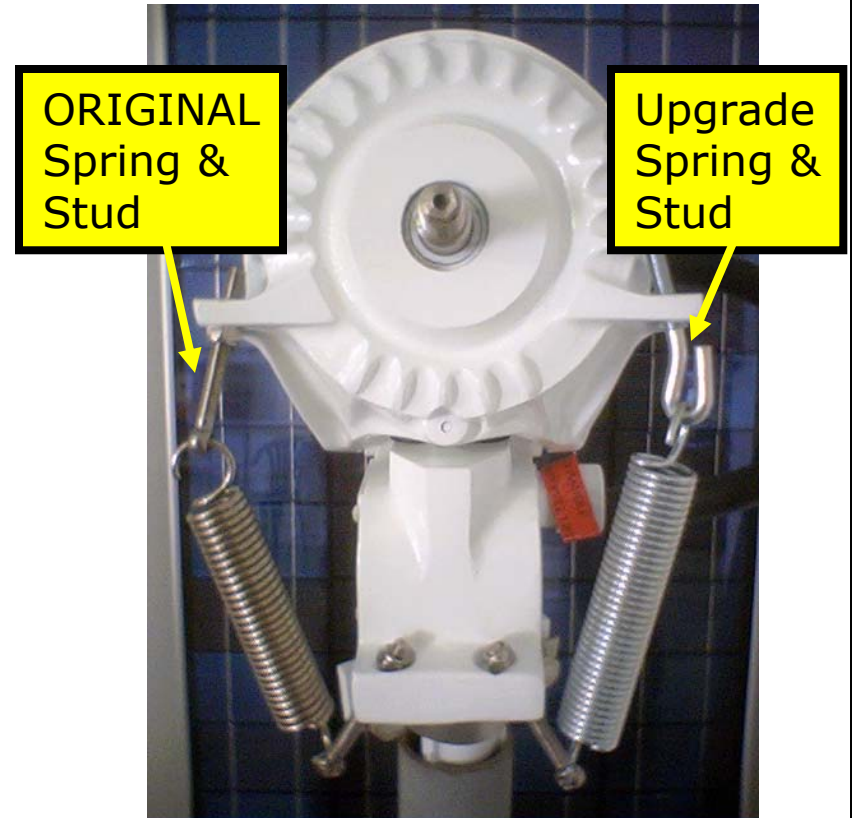
REFER TO PHOTO AT RIGHT

Early LAKOTAs made prior to 2006 had standard coil springs but in early 2005 some were shipped with springs that were about 18-22% stronger than specification. You can identify these “too-strong” springs because the loops at either end are off-set by 90 degrees instead of being “in-line”. These springs should not be used, especially in high wind sites. The stronger springs tend to make the turbine furl late in high winds and can shorten the life of your turbine. Also, the softer spring material was prone to breaking off at the upper spring hook or loop. Both spring and upper stud should be replaced with an available kit as soon as practical.

The older stainless upper spring stud attachments sometimes had sharp edges that would chew through the softer spring material and break the upper loop of the spring if high frequency vibrations are present due to extreme wind and poor blade balancing. This is most noticeable if your blade tips are not mounted exactly equidistant when you installed them.

The spring and attachment on the left is the older design and BOTH sides should be replaced as shown on the right. The spring loops should go through the stud loops from back to front as shown.

Make sure the new upper stud goes almost all the way IN and the lower stud is all the way OUT. The spring should be snug but NOT EXTENDED. The UPPER LEFT stud on some castings may require you to file a notch to allow the stud to go fully IN.
